Source: Mountain Research and Development, 29(3):202-210.

Risk-conscious Reconstruction in Pakistan-administered Kashmir

A Case Study of the Chakhama Valley

Markus N. Zimmermann^{1*} and Shireen S. Issa²

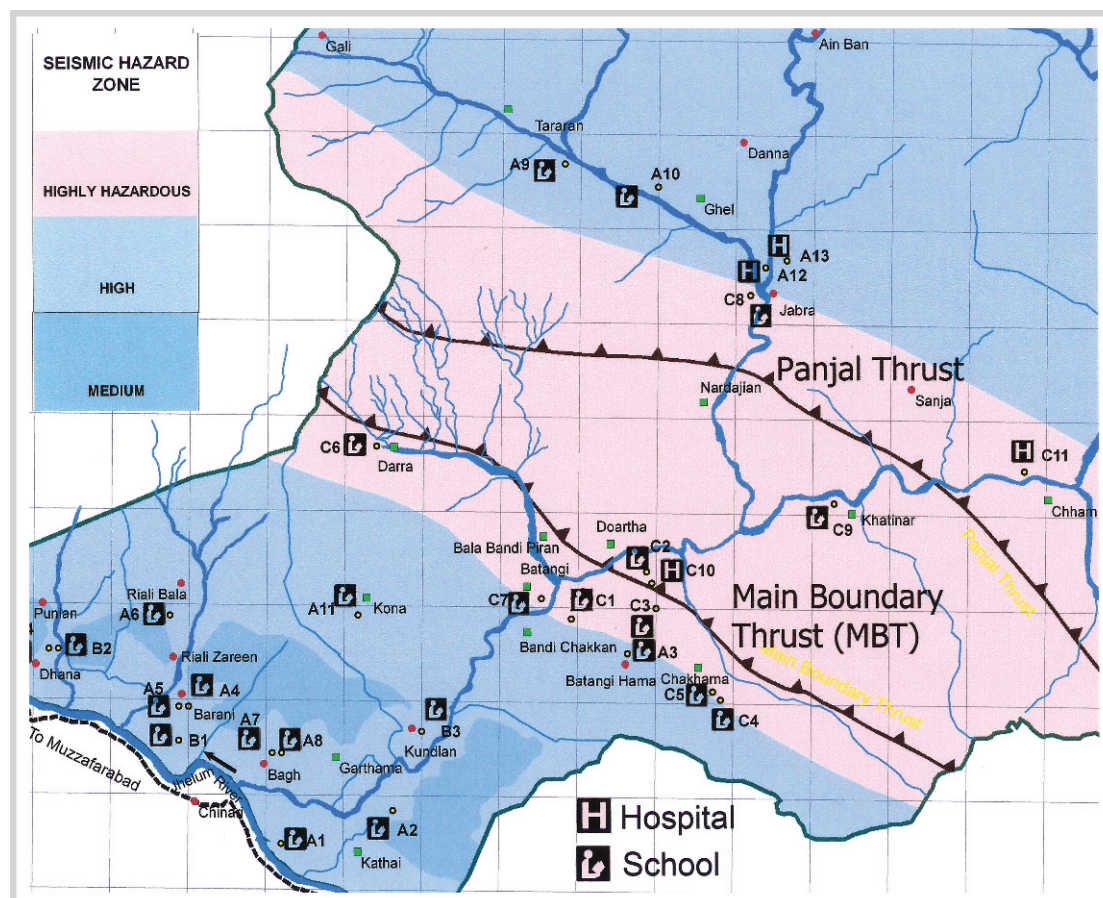
FIGURE 4 Earthquake microzonation map for Chakhama with main fault lines and essential infrastructure (schools, basic health units). Maps at a scale of 1:10,000 and 1:25,000 are also available for effective planning. (Source: NESPAK 2007, original scale 1:50,000)

Bandi Chakan is located about 1 km southwest of one of the main fault lines (MBT; see Figure 4). Part of the village is categorized as being in a highly hazardous seismic zone, with the remaining area lying in the high seismic zone category. Earth shaking has resulted in significant slope instability in the areas above the village.
